City of Rutland Sidewalk Inventory Report

2012-2013

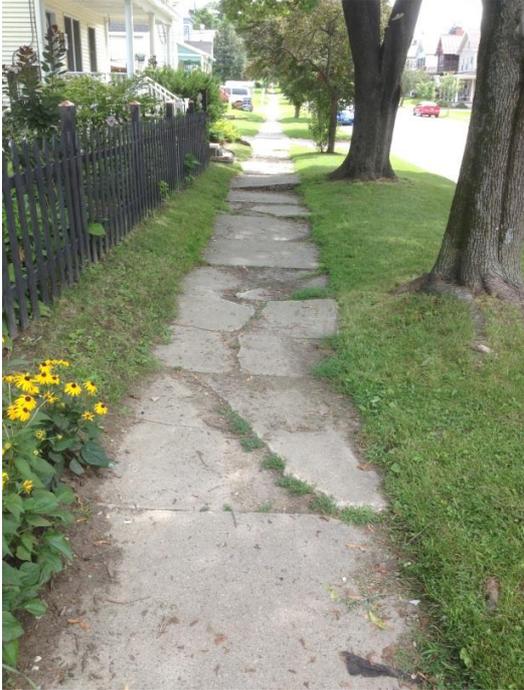
<u>Condition</u>		<u>Factor</u>
Failed	Sidewalk in complete deterioration; impassable	1.0
Poor	Sidewalk mostly deteriorated or heaved; not ADA compliant; possibly passable	0.75
Good	Sidewalk not heaved; slight cracking at most; ADA compliant	0
Excellent	Sidewalk has no cracks; in as-poured condition	0
